OCTOBER 1963

# approach

THE NAVAL AVIATION SAFETY REVIEW

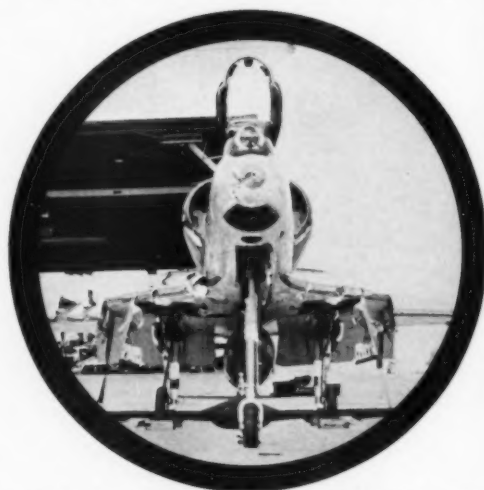
This battered SKYHAWK survived a tangle with a Springing Limbiscus tree.

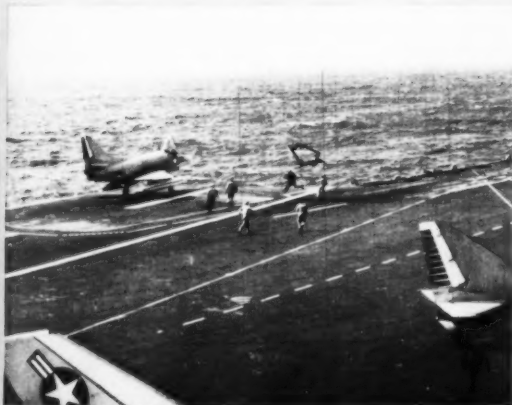
The right brake failed after a normal arrestment. The nose wheel castered and the aircraft rolled forward parallel to the waist catapult. Apparently the starboard brake hose had slipped on the strap assembly which allowed the brake line to either hang up on gear extension or caused the catapult bridle to hit the line. The line was crushed which rendered the right brake inoperative. This occurrence initiated a rapid series of events which, except for a fast acting deck hand and an extreme amount of luck, could easily have resulted in the loss of an aircraft and possibly a pilot.

Well done to an alert crewman who threw a chock at the wheel and possibly averted the loss of a pilot and aircraft.

The squadron recommended several actions that could have been taken which might possibly have prevented this aircraft from reaching that perilous resting place. These include: securing the engine; lock the left brake (*although this may have sent the aircraft into the port catwalk—Ed.*); or raise the landing gear.

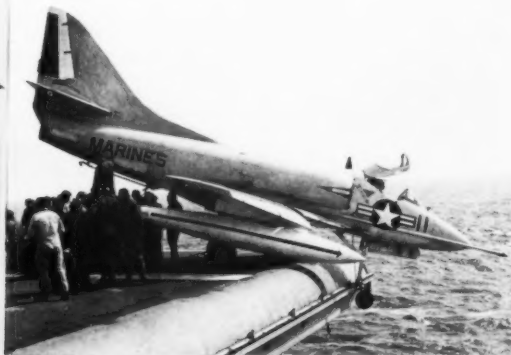
The aircraft came to rest when the nose strut jack pad caught in the drain gutter that surrounds the carrier.

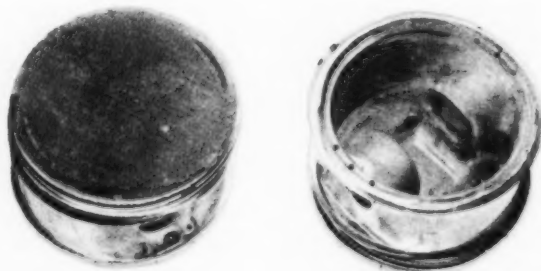
FIGURE 1: These pistons were removed from an R1820-86 engine with 366.0 hours since overhaul using 100 sec ashless dispersant oil. Note the lack of coke deposits in the ring lands and undercrown. The oil holes were clear of any blockage material.

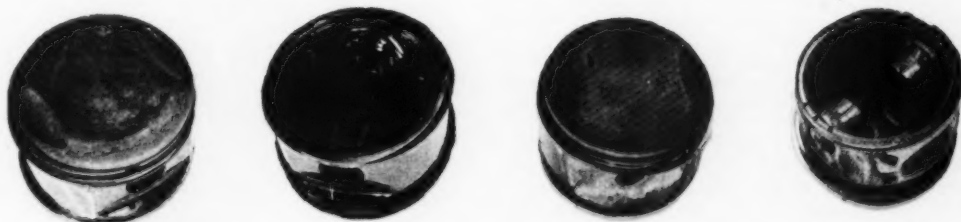
be extremely dirty. Heavy, hard and semi-hard, coke and sludge accumulations were present throughout the engine lubricating system. The hard coke particles would collect on the filters and in most cases induce bypassing. A majority of engine failures were found to be caused from worn or seized master rod bearings.

FIGURE 2 (LEFT): These pistons were removed from an R1820-86 engine that had accumulated 158.1 hours since overhaul with MIL-L-6082 Grade 1100. Compare these deposits with those in FIGURE 1 (page 34). FIGURE 3 (RIGHT): Pistons removed from an R1820-86 engine that had accumulated 839.4 hours since overhaul. The last 318.9 hours were on 100 sec ashless dispersant oil. Note the reduced amount of deposits in the ring lands and grooves. The oil holes were open.

In conclusion, the results that have been attained to date justify changing to the dispersant oil on all reciprocating engine powered aircraft. Water in any concentrated form may present a problem but by observing the minimum practices of good quality control, this problem can be eliminated.

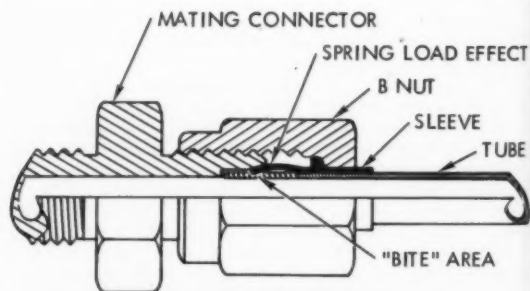
**FLARELESS TUBE CONNECTION**  
(installed and tightened)

When a B-nut on a hydraulic, pneumatic, pitot-static or instrument line is found to be leaking or is suspected of leaking, the natural tendency is to tighten it. This tendency is a carry-over from earlier aircraft on which flared tube connections were used.

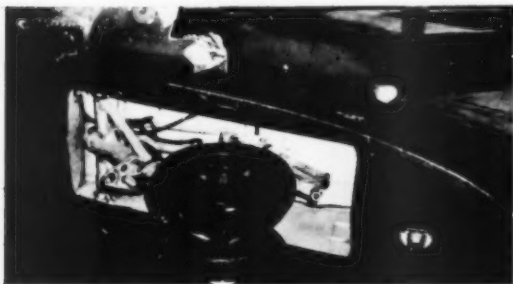
Upon coming along side the ship attempted salvage efforts for some two hours while the chopper remained near the surface buoyed by its sponsons. A bridle attached to the port and starboard sponsons was then hooked to the ship's crane. Upon lifting the inverted water-filled hull the sponsons were torn off the airframe. Necessary flotation was lost and the aircraft sank in 2050 fathoms

Sponsons were shorn during lift attempt.
